Project No. 17715

March 13, 2020

Re: Foundation Evaluation
[REDACTED]

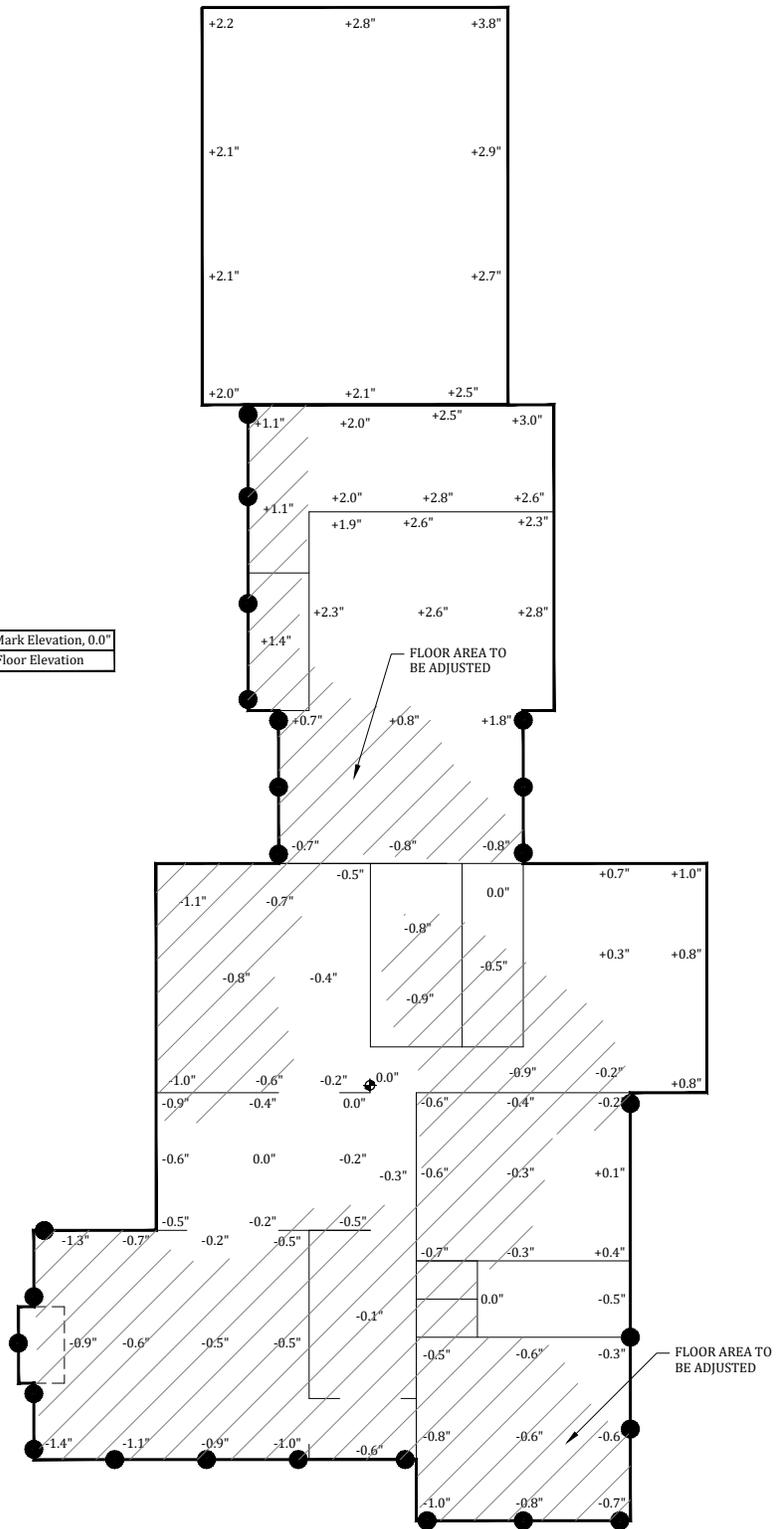
FIGURE 1

An interior floor elevation survey was performed on the living area of the house, with the elevations recorded to the nearest 10th of an inch (0.1”). Adjustments were made to account for the thickness of the floor coverings. A benchmark elevation of 0.0 inches was established near south east corner of the kitchen as shown in Figure 1 of this report.

Based on our observations of the interior and exterior cosmetic distress, the floor elevations and calculations, it is our opinion that the house has undergone an excessive amount of movement. The maximum differential deflection is 1.5 inches and occurred over an approximate distance of 30.0 feet. This amount of deflection exceeds the standard allowable deflection of 1.0 inches for a distance of 30.0 feet. The standard allowable differential deflection is based on 1.0 inch of vertical movement, up or down, over a horizontal distance of 30 feet; expressed as Length (in inches)/ 360.

- 1) To stabilize and lift the perimeter foundation wall, install (25) perimeter piles or drilled piers as show on Figure 1 of this report. The piles can be concrete cylinders, steel pipe, or helical screws. Refer to Figures 3, 4, 5 and 6 of this report. Space the piles or drilled piers along the perimeter foundation at a maximum of 6 feet on-center. Note, any foundation movement, even corrective movement, can cause additional cosmetic distress.
- 2) Replace cracked floor beam with same size beam using pressure treated SP #2 lumber.
- 3) Re-plumb the leaning piers.
- 4) Adjust the crawlspace piers as required, using metal shims, to achieve a more level condition between Bedrooms 2 and 3 and in the Kitchen. It is recommended that all wood shims be replaced with metal shims due to the wood shims can be damaged over the years.

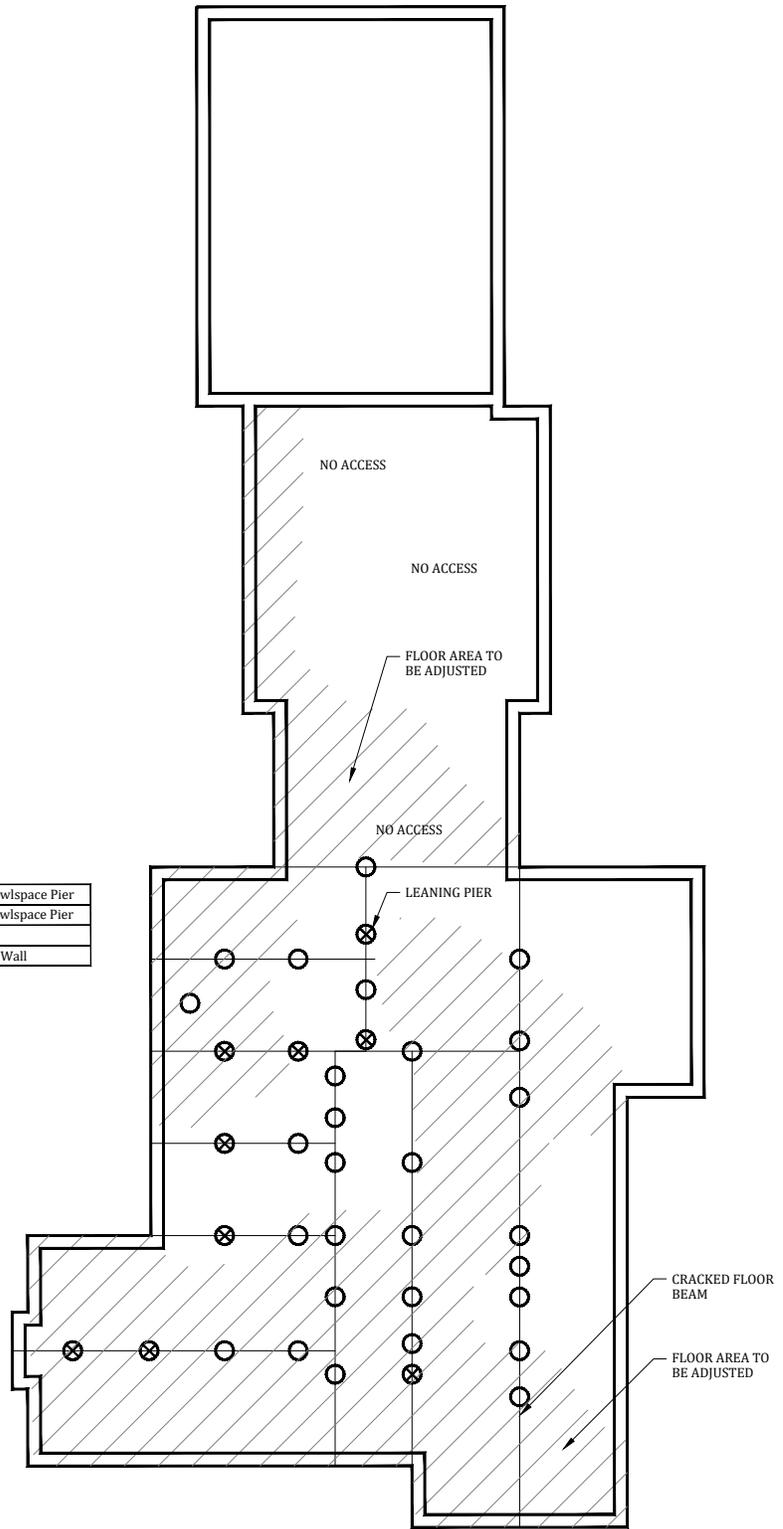
FIGURE 2

- Cracked floor beam
- Leaning piers
- 2x lumber shims
- Stacked 2x lumber shims
- Piers not centered under floor beam they support
- Vertical 2x lumber piers bearing directly on soil
- Misaligned floor beams, the elevation along the tops of the beam do not match
- Leaning piers
- Inadequately supported ends of floor beams at piers
- Misaligned pier with a cantilevered brick to support floor beam
