Project No. 18523

April 8, 2020

Re: Foundation Evaluation

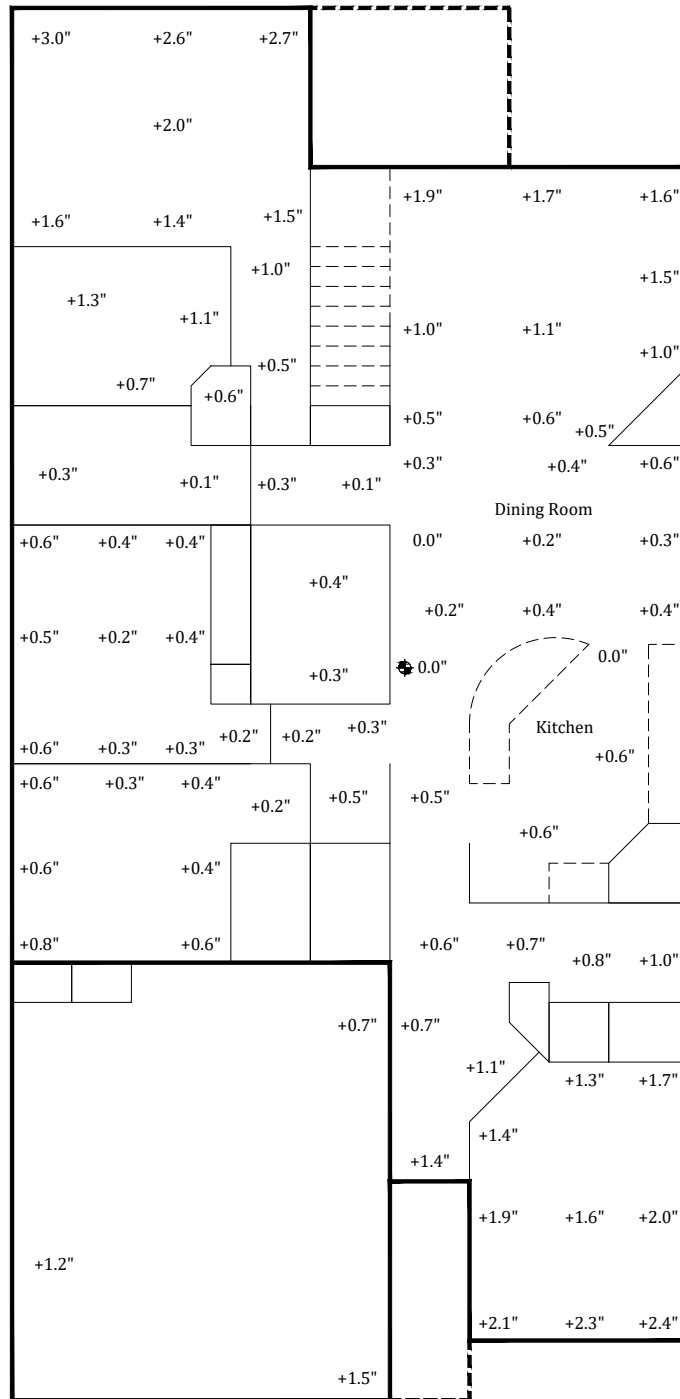
FIGURE 1

An interior floor elevation survey was performed on the living area of the house, with the elevations recorded to the nearest 10th of an inch (0.1"). Adjustments were made to account for the thickness of the floor coverings. A benchmark elevation of 0.0 inches was established near the northwest corner of the kitchen as shown in Figure 1 of this report.

Based on our observations of the interior and exterior cosmetic distress, the floor elevations and calculations, it is our opinion that the house has undergone an excessive amount of movement. The maximum differential deflection is 1.6 inches and occurred over an approximate distance of 40.3 feet. This amount of deflection exceeds the standard allowable deflection of 1.3 inches for a distance of 40.3 feet. The standard allowable differential deflection is based on 1.0 inch of vertical movement, up or down, over a horizontal distance of 30 feet; expressed as Length (in inches)/ 360.

It should be noted that the foundation is relatively level throughout the house, but at higher elevations in the interior of the house near the front and rear exterior walls. Due to the higher

elevations in these areas remedial measures, such as structural underpinning, would require lifting the remaining area of the house and therefore not recommended at this time. It is our opinion that before remedial measures are used the Foundation Maintenance Recommendations should be performed and maintained for 6 to 12 months to determine if the recommendations correct any of the current elevations.
