Project No. 18894

Re: Foundation Evaluation

As requested, personnel of GreenWorks Engineering and Consulting have completed an observation of the foundation at the address referenced above on April 21, 2020. The purpose of the observation was to collect information necessary to assess the performance of the existing foundation. This evaluation was a Level B evaluation as described in the "Guidelines for the Evaluation and Repair of Residential Foundations" by the Texas Section of the American Society of Civil Engineers (ASCE). For the purpose of this report the house faces west.

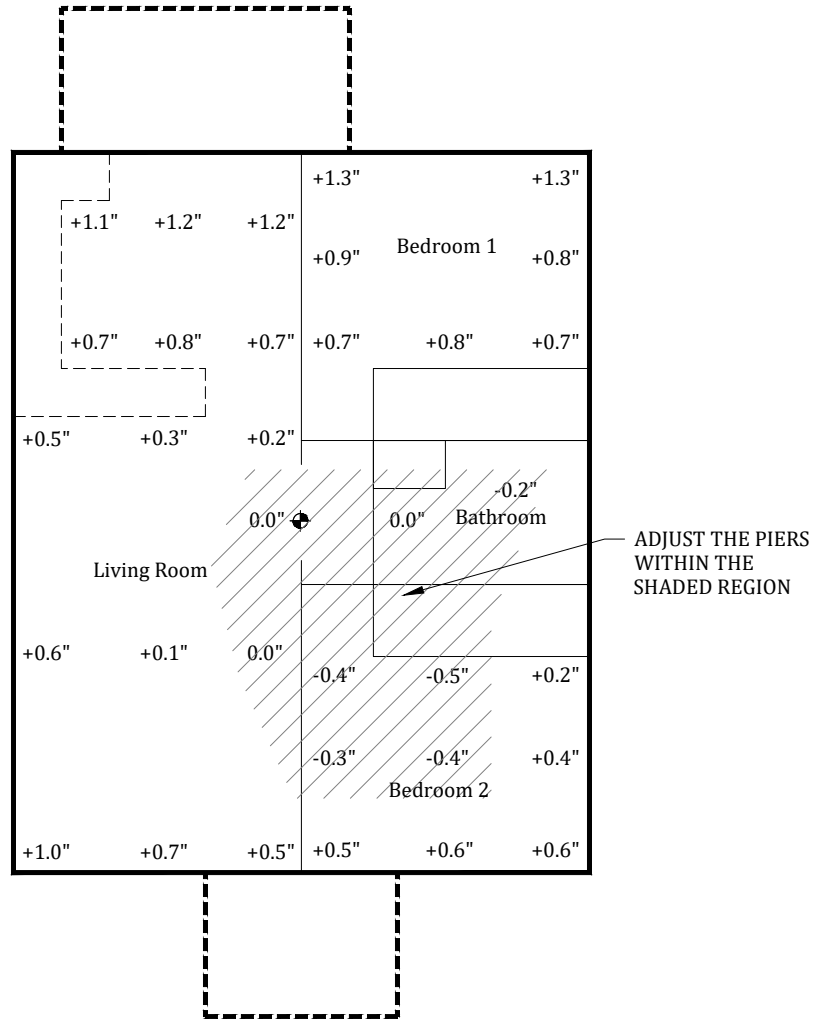
FIGURE 1

An interior floor elevation survey was performed on the living area of the house, with the elevations recorded to the nearest 10th of an inch (0.1"). Adjustments were made to account for the thickness of the floor coverings. A benchmark elevation of 0.0 inches was established on the north wall of the living room near the hallway as shown in Figure 1 of this report.

Based on our observations of the interior and exterior cosmetic distress, the floor elevations and calculations, it is our opinion that the house has undergone an excessive amount of movement. The maximum differential deflection is 0.6 inches and occurred over an approximate distance of 11.8 feet. This amount of deflection exceeds the standard allowable deflection of 0.4 inches for a distance of 11.8 feet. The standard allowable differential deflection is based on 1.0 inch of vertical movement, up or down, over a horizontal distance of 30 feet; expressed as Length (in inches)/ 360.

- 1) Adjust the crawlspace piers as required, using metal shims, to achieve a more level condition between Living Room, Bathroom, and Bedroom 2. It is recommended that all wood shims be replaced with metal shims due to the wood shims can be damaged over the years.
- 2) The existing CMU block piers should bear on a 16"x16"x4" masonry block.
- 3) Adjust or replace the existing (2) 2x6 beam with a new (2) 2x6 pressure treated No. 2 beam.
- 4) Adjust the existing block piers that have shifted to a plumb condition.
- 5) With the completion of the foundation underpinning, a final elevation survey must be performed to provide a final elevation baseline. It is recommended to review the performance of the foundation every 6 to 12 months. Compare all future foundation evaluations to this baseline.

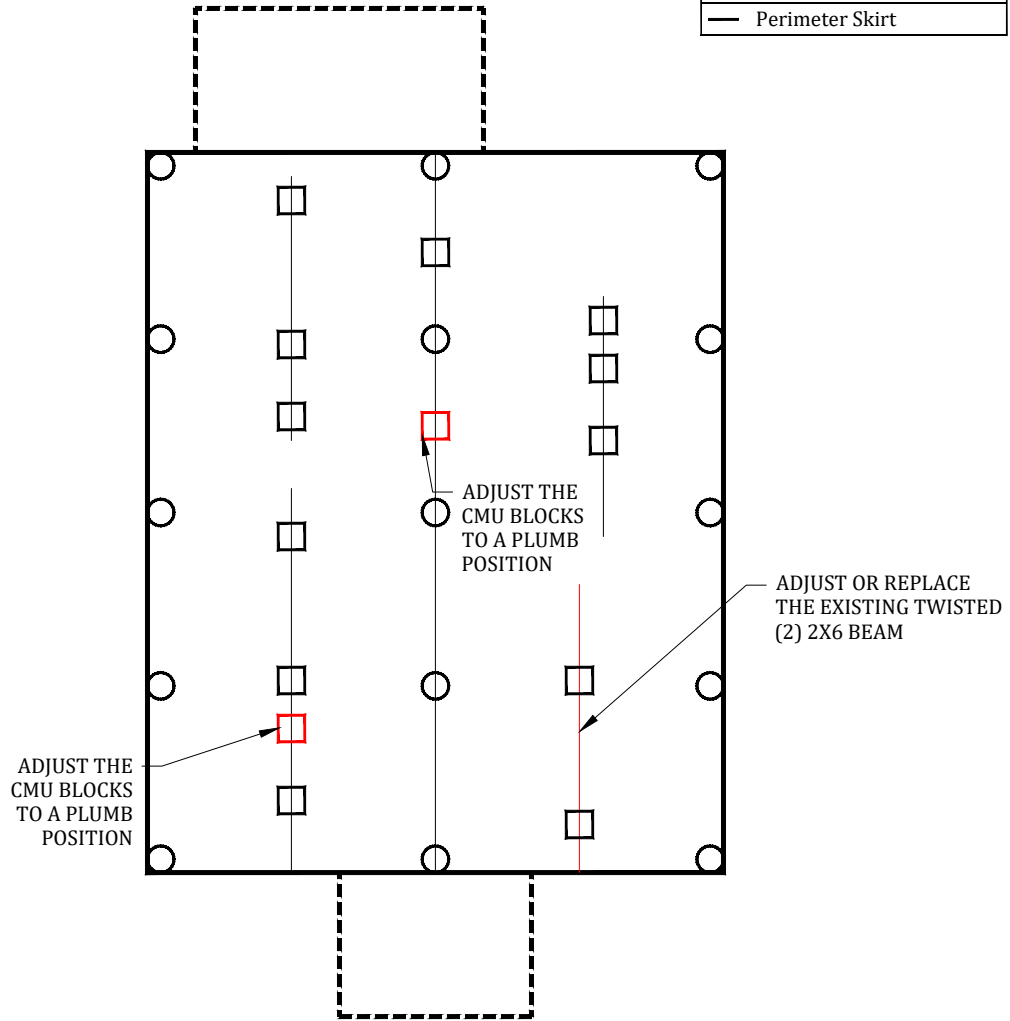
FIGURE 2

- Wood shims are used between the concrete blocks and the wood beams
- The (2) 2x6 beam at the south side of the interior of the residence appears to have twisted
- There are stacked CMU blocks that have shifted and are not level

- The CMU blocks were stacked with no base or footer
