Project No. 17459

March 13, 2020

Re: Foundation Evaluation

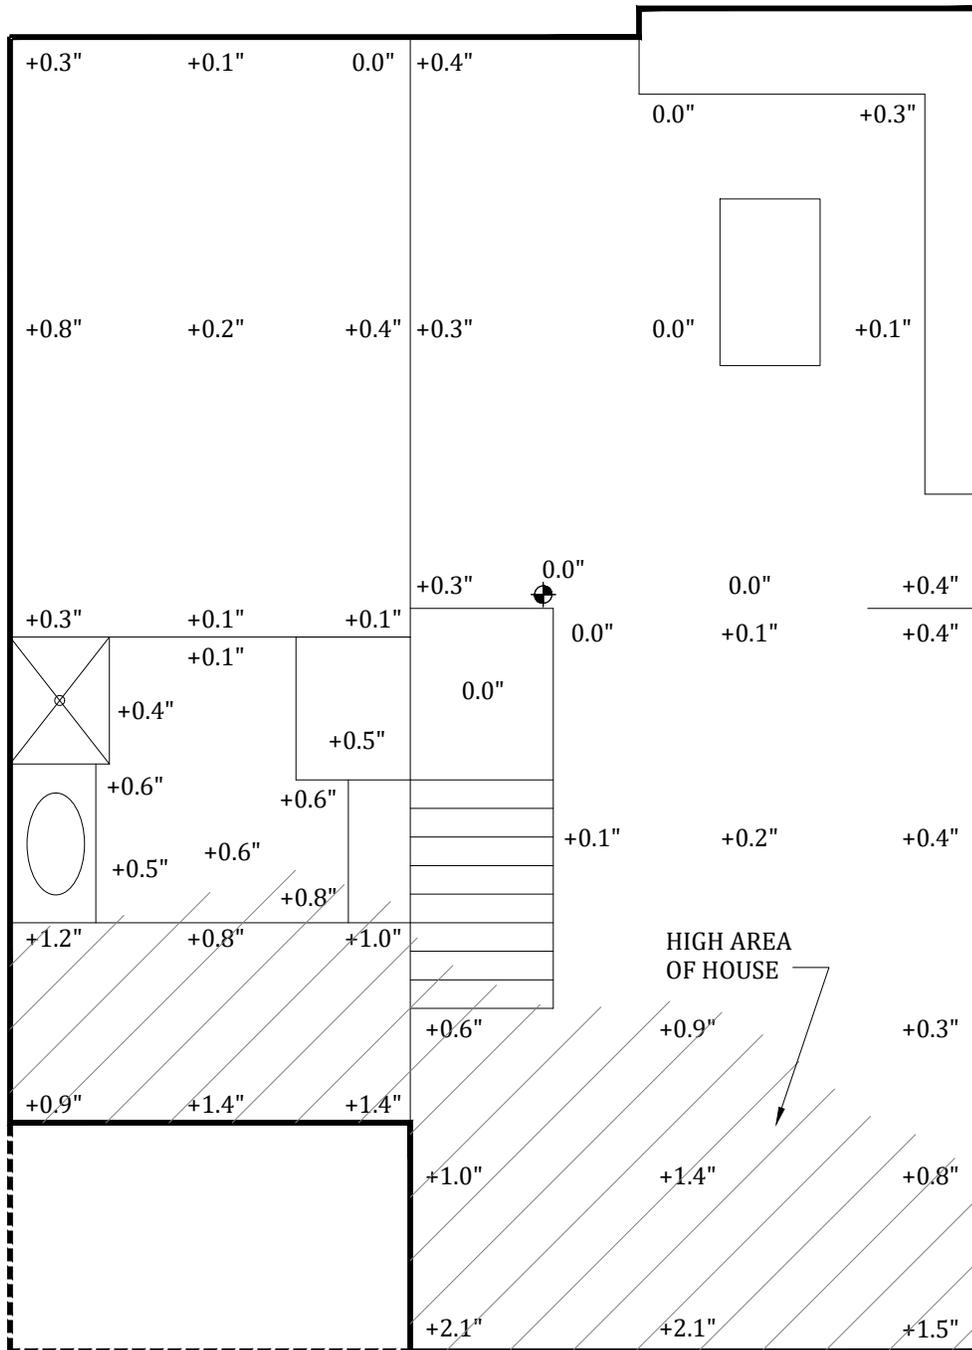
**FIGURE 1**

An interior floor elevation survey was performed on the living area of the house, with the elevations recorded to the nearest 10<sup>th</sup> of an inch (0.1"). Adjustments were made to account for the thickness of the floor coverings. A benchmark elevation of 0.0 inches was established near the northeast corner of the kitchen as shown in Figure 1 of this report.

Based on our observations of the interior and exterior cosmetic distress, the floor elevations and calculations, it is our opinion that the house appears to be in relatively good condition but could be due to the recent updating of the interior and exterior. However, the house has experienced an excessive amount of movement. The maximum differential deflection is 0.7 inches and occurred over an adjusted distance of 11.0 feet. This amount of deflection exceeds the standard allowable deflection of 0.36 inches for a distance of 11.0 feet. The standard allowable differential deflection is based on 1.0 inch of vertical movement, up or down, over a horizontal distance of 30 feet; expressed as  $\text{Length (in inches)} / 360$ .

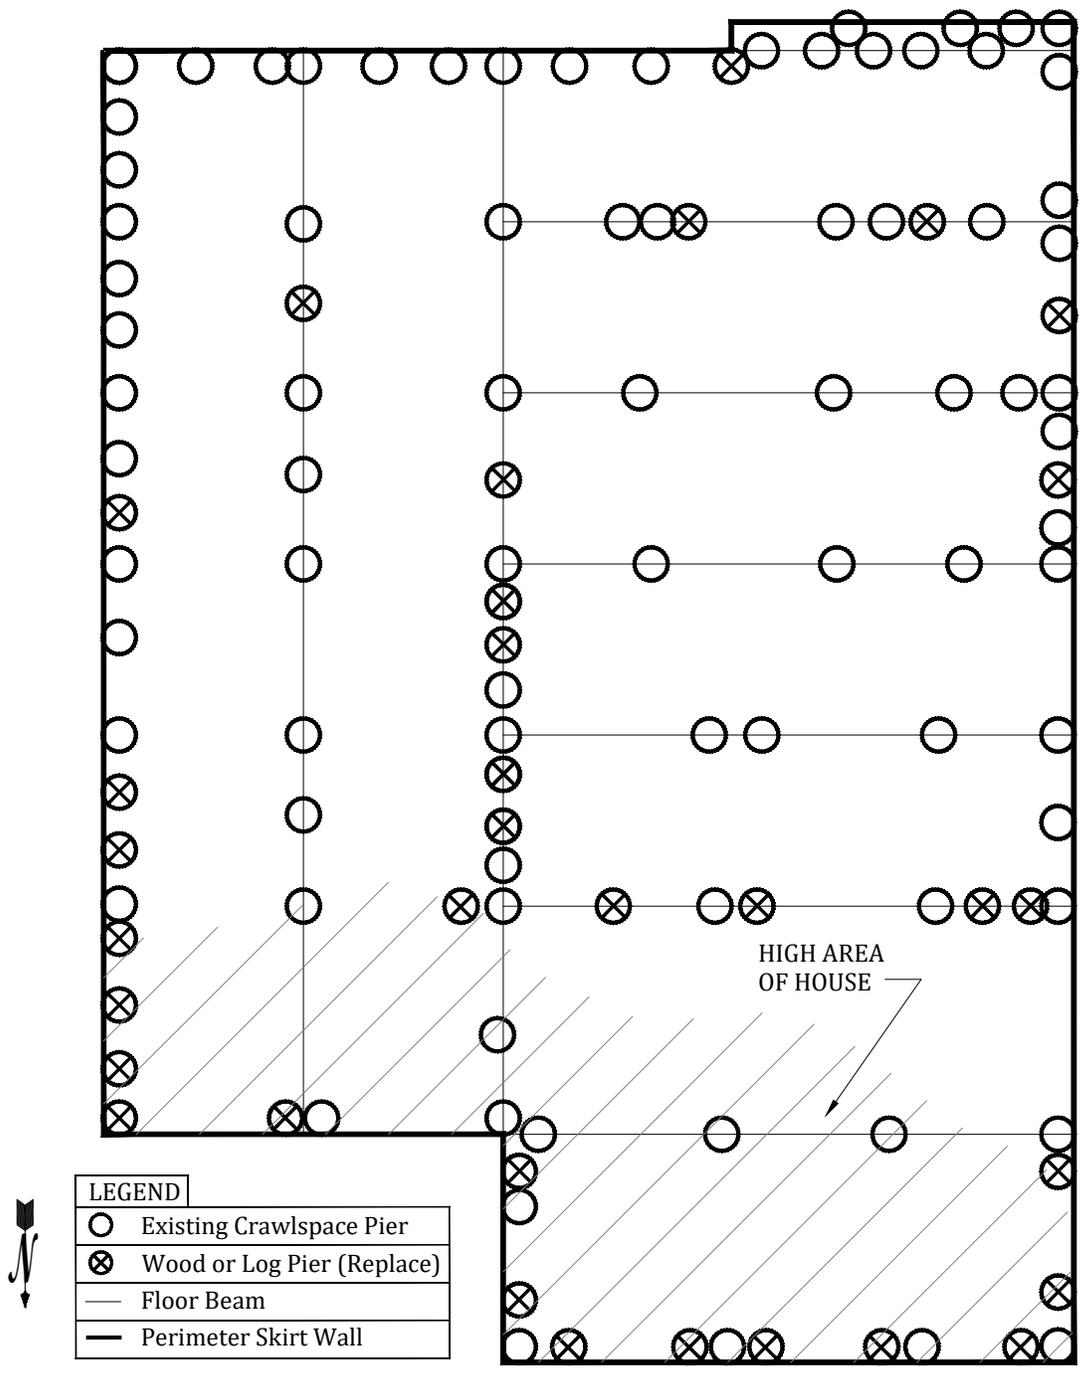
**FIGURE 2**

- Concrete piers not in contact with the floor beams that they should support
- Single 2x lumber piers in direct contact with the soil
- Floor beams not aligned vertically with adjacent floor beams
- Log piers in direct contact with the soil
- Floor beam not in contact with the floor joist it should support
- Log pier with a 2x lumber shim
- Notched floor beam for plumbing
- 2x lumber shims
- Stacked 4x4 and 2x lumber pier

- 1) Shim the crawlspace piers that are not in contact with the floor beams. It is recommended that all wood shims be replaced with metal shims due to the wood shims can be damaged over the years.
- 2) Shim between pier and floor beam that is not in contact with the floor joists above.
- 3) Replace log and lumber piers with solid concrete piers, shim tight to existing framing.
- 4) Have the doors that remain poorly functioning adjusted or rehung.
- 5) It is recommended to review the performance of the foundation as a proactive foundation maintenance program every 6 to 12 months. Retain this report as an elevation baseline for the foundation. Compare all future foundation evaluations to this baseline.
