Project No. 18723

April 20, 2020

Re: Foundation Evaluation

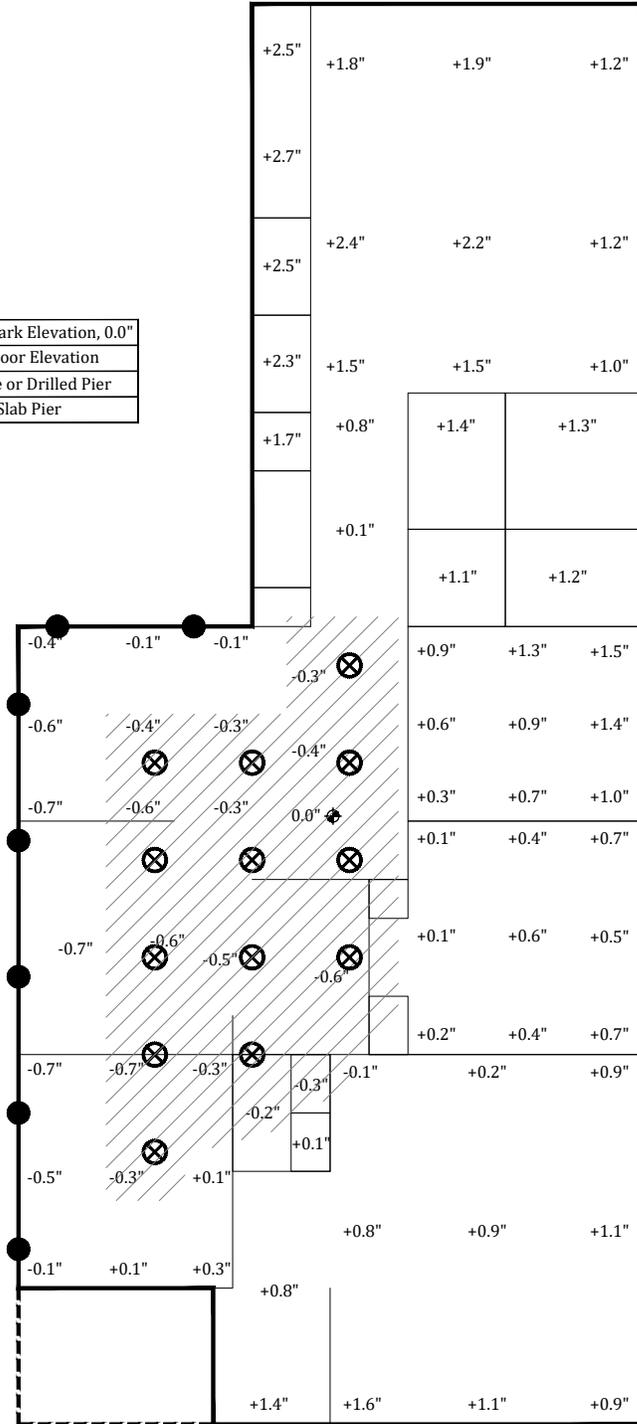
FIGURE 1

An interior floor elevation survey was performed on the living area of the house, with the elevations recorded to the nearest 10th of an inch (0.1"). Adjustments were made to account for the thickness of the floor coverings. A benchmark elevation of 0.0 inches was established near the center of the house as shown in Figure 1 of this report.

Based on our observations of the interior and exterior cosmetic distress, the floor elevations, and calculations, it is our opinion that the house has undergone an excessive amount of movement. The maximum differential deflection is 0.8 inches and occurred over an approximate distance of 15.3 feet. This amount of deflection exceeds the standard allowable deflection of 0.5 inches for a distance of 15.3 feet. The standard allowable differential deflection is based on 1.0 inch of vertical movement, up or down, over a horizontal distance of 30 feet; expressed as Length (in inches)/ 360.

- 1) To stabilize and lift the perimeter foundation wall, install (7) perimeter and (13) interior piles or drilled piers as shown on Figure 1 of this report. The piles can be concrete cylinders, steel pipe, or helical screws. Refer to Figures 2, 3, 4, and 5 of this report. Space

the piles or drilled piers along the perimeter foundation at a maximum of 7 feet on-center and within the interior at a maximum of 5 feet on-center. The number of interior piers may be reduced if the interior grade beams are located prior to the foundation underpinning. The interior piers shall be placed at the intersections of the grade beams and placed at a maximum of 8 feet on-center. Note, any foundation movement, even corrective movement, can cause additional cosmetic distress.
